Inventory No.F-4-49
Ramsburg-Gaver Farmstead
4234 Crow Rock Road
Frederick County, MD
Ca. 1850

ADDENDUM TO 1992 MARYLAND HISTORIC SITES INVENTORY FORM

1. Name of Prop	erty (indicate preferred n	ame)	
historic Rams	burg-Gaver Farmstead (preferred)	(MIHP update of	1992 form)
other Shelte	r Rock Farm		
2. Location		3	
street and number 4234	Crow Rock Road		not for publication
city, town Myers	sville	<u>X</u>	vicinity
county Maryl	and

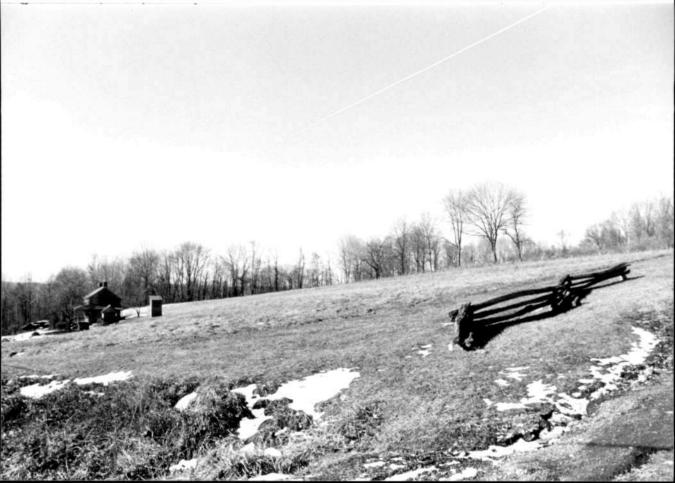
F-4-49 Ranging - Ciacar Farmstead Frederick Co., MD E. Wollace 1-03 MOSHPO Overall trem of NW section of forms -000, View W

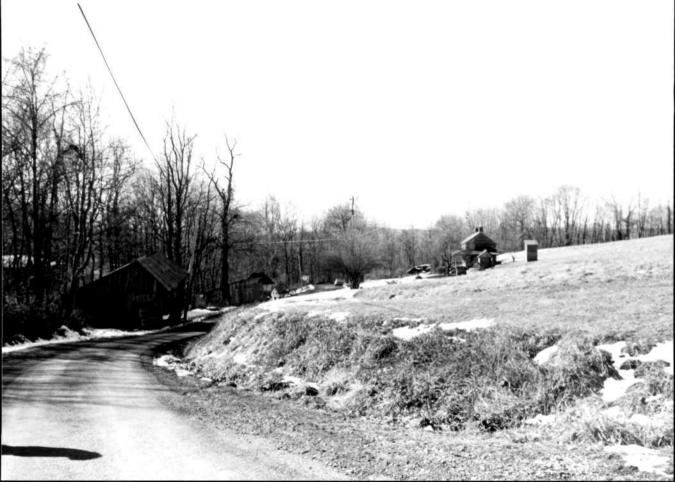
F- 4-49 Romsburg - Gavex formstead Frederick Co., MD E. Walloce MOSHPO View of SW section of formstead, view W.

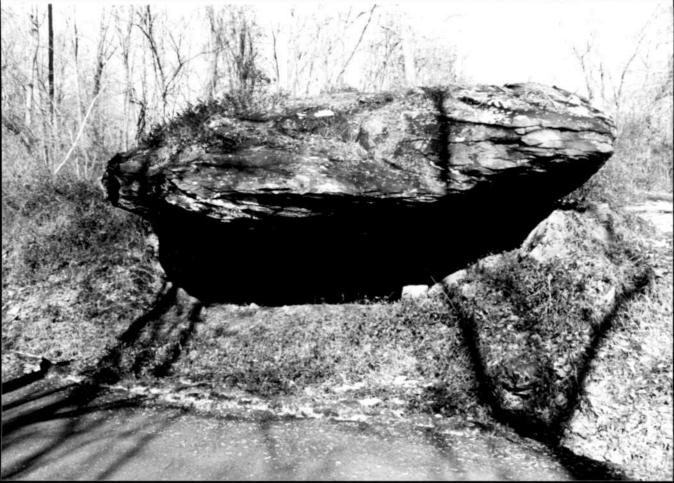
F-4-49 Romsburg-Gaver Formstead Frederick Co., MD Wallace MPSHPO Shotter Rock Rock Shelter (18FR431), View N

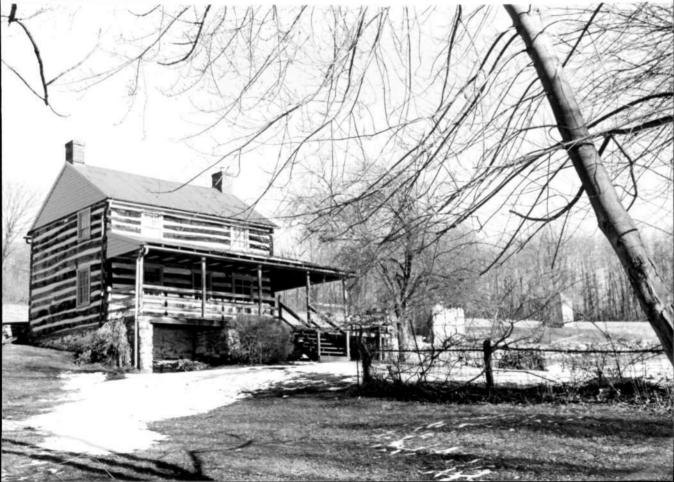
F-4-49 Rumsburg - Gover formstead Frederick Co., MD E. Wallace 1-03 MOSHPO Main house and outbuildings, Wand S elevations View NE

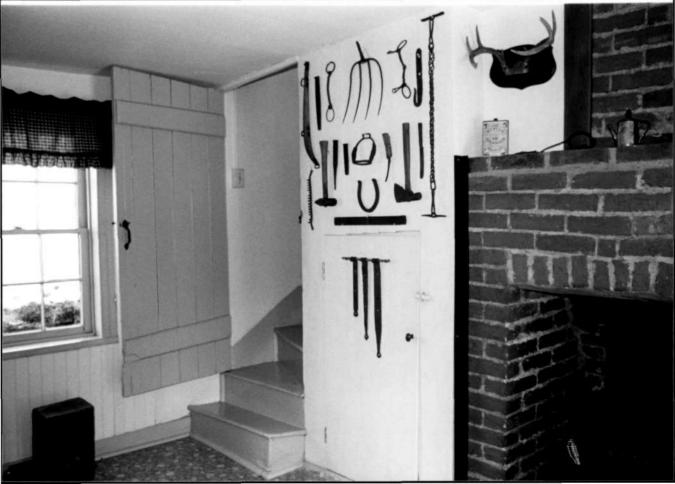
F- 4-49 Rumsburg-Gaver Formstead Frederick Co., MD E. Wallace 1-03 MOSHPO Main house interior, first floor Kitchen, view toward NE councer

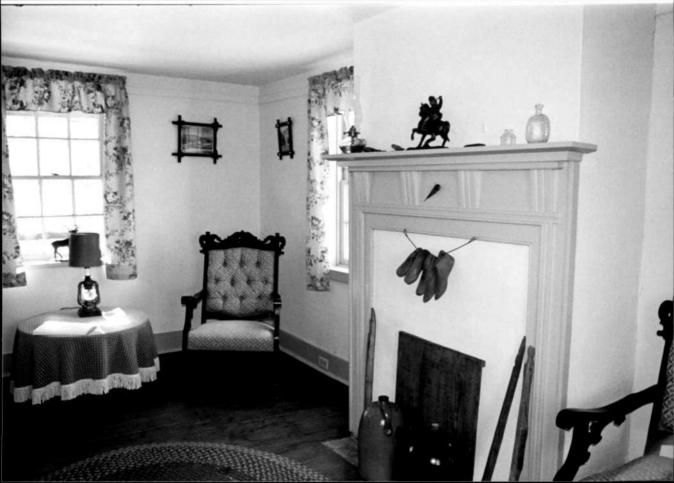
Ramsburg - Gover Formstead Frederick Co., MD E. Walloce MOSHPO Main house interior, first foor parlor, view toward Sw corner 4/25

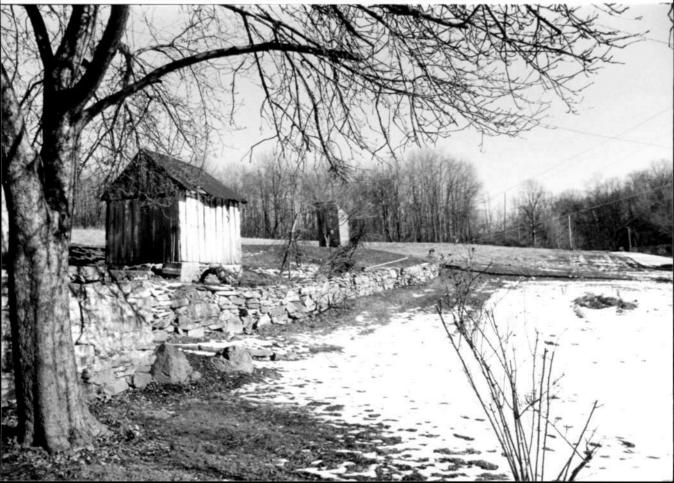
F- 4-49 Rumburg - Gaver Formstead Frederick Co., MD E. Wollace 1-03 MOSHPO Smokehouse and privy, wand S elevations VIEW E

Smokehouse: The frame smokehouse is located east of the house and has a generally square plan with vertical and composition siding and a corrugated metal gable roof. The door in the west elevation is vertical boards. The structure probably dates from the last quarter of the 19th century.

Privy: The frame privy is located east of the smokehouse. It has a square plan with vertical siding and a corrugated metal shed roof. The door in the west elevation is vertical boards. The privy is also a late 19th century structure and is in deteriorated condition.

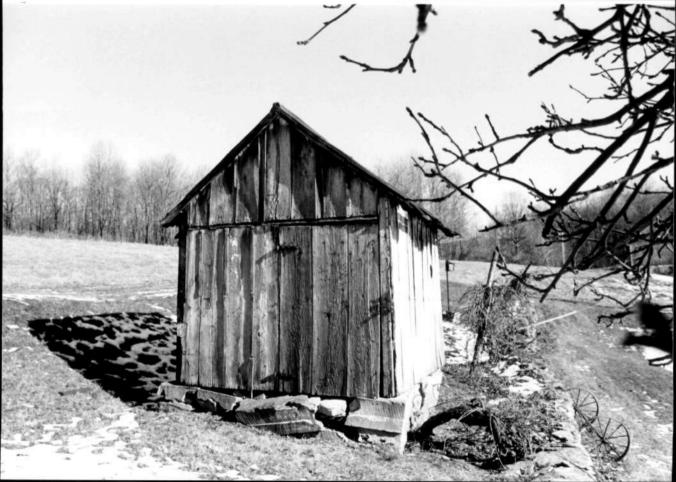
F-4-49 Rumsburg-Garrer Formstead Frederick Co., MD Et. Wallace 1-03 MOSHPO Smokehouse W elevation, view E

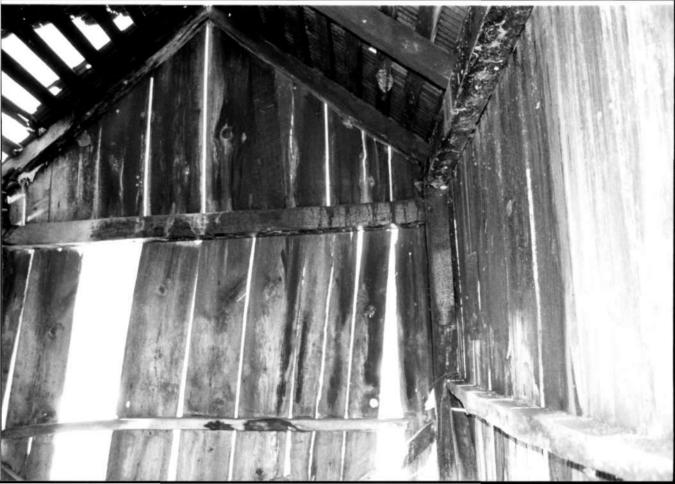
F-4-49 Ransburg-Gover Formstead Frederick Co., MO E. Wallace 1-03 MOSHPO Smokehouse interior, E wall

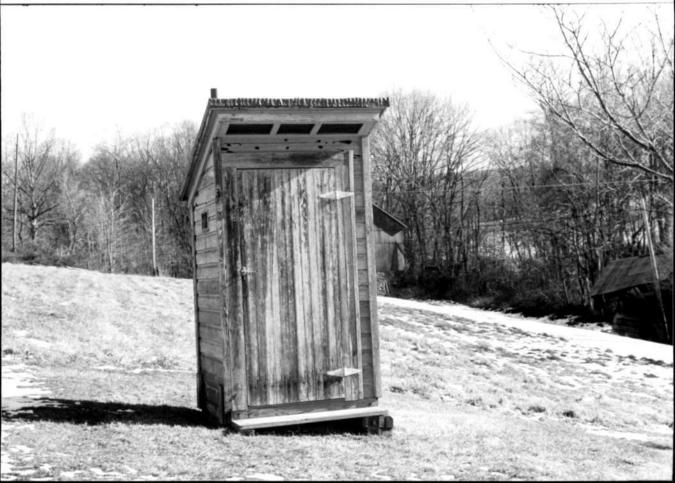
F 4-49 Rumsbrg-Gaver Formstead Frederick Co., MD E. Wallace 1-03 MOSHPO Privy, W elevation, view SW

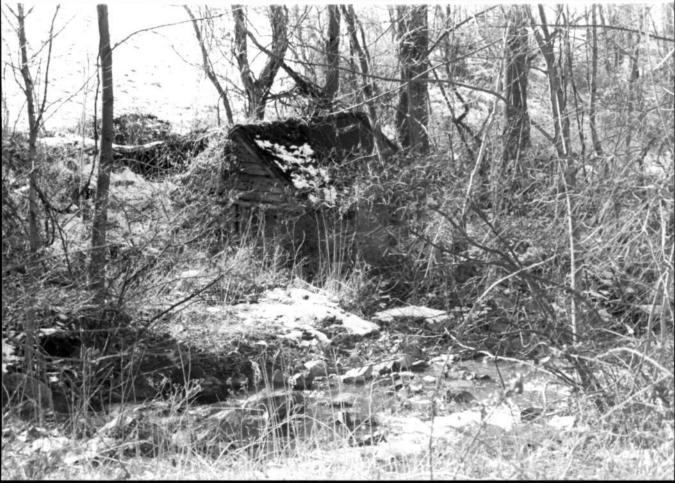
F-4-49 Ramsburg-Gaver Farmstead Frederick Co, MD E. Wallace MOSTIPO Springhouse, S bank of creek, view SW

Springhouse: The stone and frame springhouse is located on the south side of the stream and Crow Rock Road about 200 feet southwest of the house. It has a stone lower section and a gable roof supported by frame gables with german siding. An overhanging eave extends on the north side of the building. The spring is located east of the structure and flows through an interior trough in the lower level. The springhouse may be an 1850's building in its original form, with the frame upper section a later addition or remodeling of the original roof.

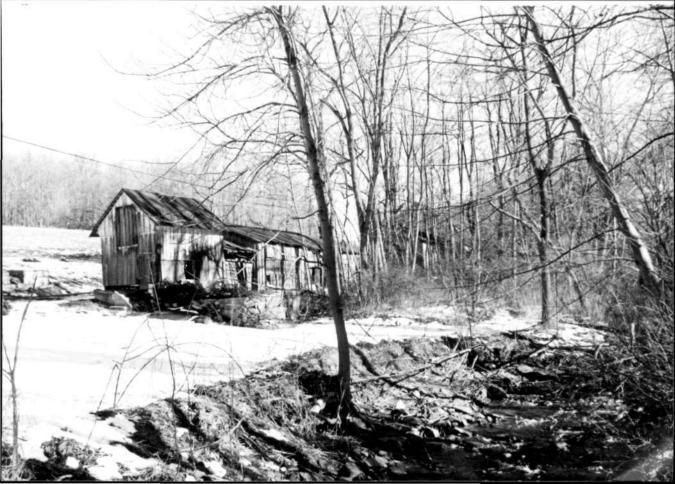
F-4-49 Ramsburg - Gaver Farmstead Frederick Co., mo E. Wallace MOSHPO Hos shed dricken house, ward S elevations view NW

Hog barn, chicken house, and feed shed: These three frame buildings adjoin each other on the south side of Crow Rock Road southeast of the house. Each has vertical siding with traces of whitewash visible near the eaves. The hog pen has a corrugated metal gable roof and several feeding doors which open in drop sections on the north elevation. These doors are horizontal boards. A second section next to the hog barn has a similar arrangement in a narrower facade. The chicken house has a shed corrugated metal roof with windows on the south elevation. The siding is board and battens. At the east end of the adjoining structures is a frame feed shed with board and batten siding and a vertical board door on the north elevation. This group, like the other agricultural outbuildings, dates from the last quarter of the 19th century.

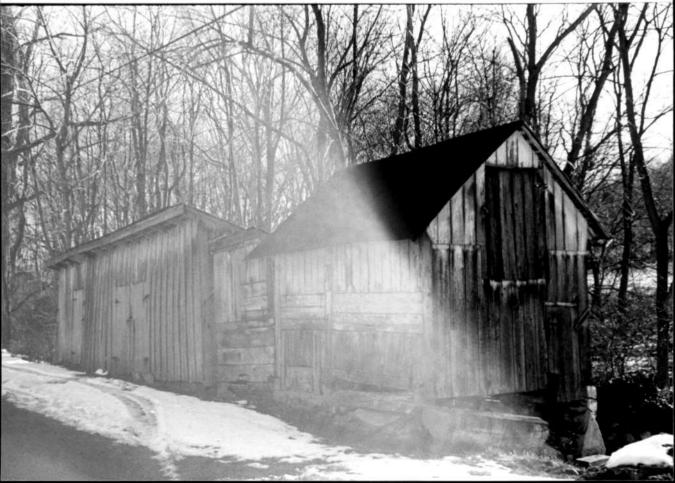
F- 4-49 Ransburg - Gaver Farnstoad Fraderick Co., MD E. Wallace Hog shed/chicken house, N and W elevations, view

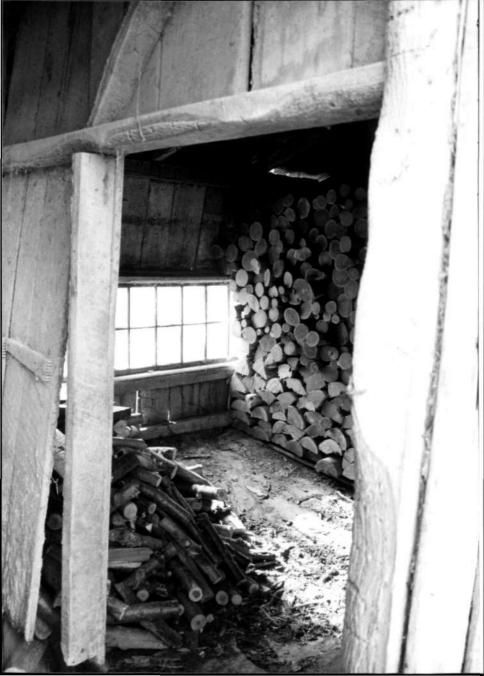
E-4-49 Ramsburg - Gaver Formstead Frederick Co., MD E. Wallace 1-03 MDSHPO Chicken house interior, view Sw

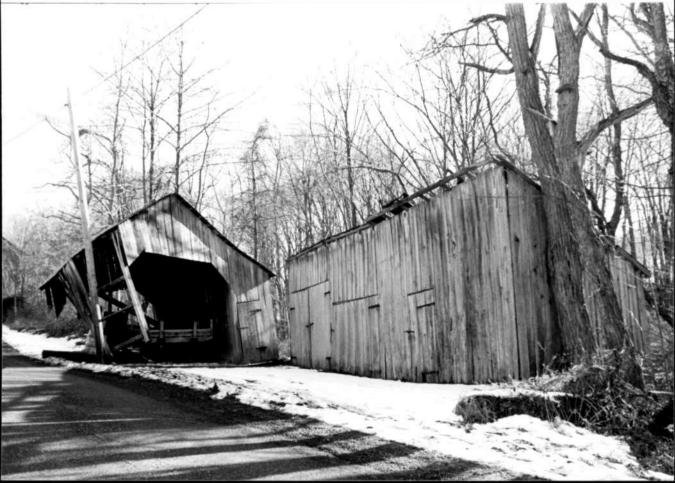
F-4-49 Ramsburg-Gaver Formstead Frederick Co., MD E. Wallace Blacksmith shop/shed/aprage and Wagonshed/connerib. Wand Melevations, view SE

Blacksmith shop, wagon shed, and garage: The second group of adjoining structures has a blacksmith shop on the west end. It has vertical board siding and a corrugated metal gable roof. The vertical board door is on the north elevation. Inside is a stone forge and the base of the anvil with scattered metal debris. The major tools were sold at auction about 1980. The shop has no outside chimney and smoke apparently escaped through the vertical boards. The adjoining wagon shed has battens over the board siding and a single doorway on the north elevation. The last building in the adjoining group is a small garage probably added during the early 20th century. It has a single swing door on the north elevation. The wagon shed and the garage both have corrugated metal gable roofs.

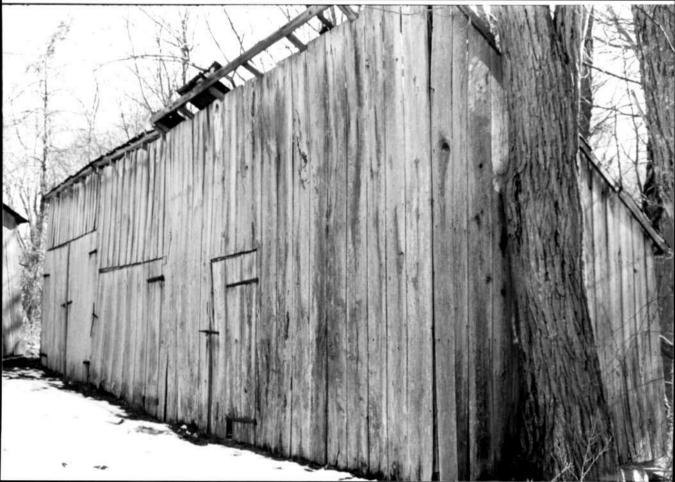
F-4-2/9 Ramsburg-Gover Formstead Frederick Co., MD E. Wallace 1-03 MDSH PO Blacksnuth shop/shed/garage, N and W elevations VIEW SE

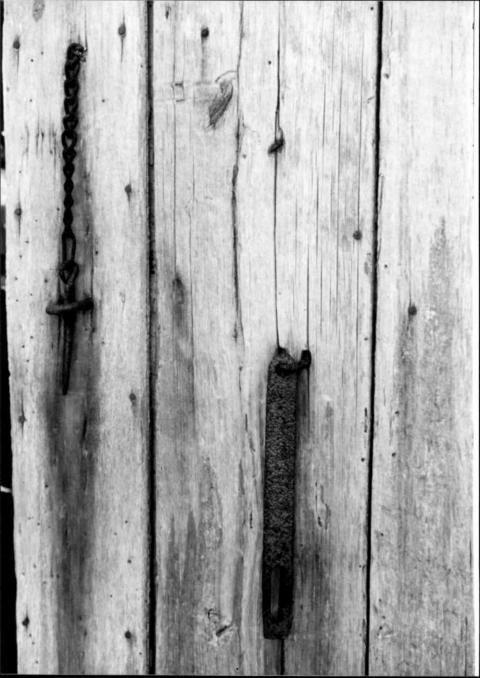
F- 4-49 Ramsburg-Gaver Formstead Frederick Co., MD E. Wallace MOSHPO Blacksmith shop/shed/garage, N elevation details hand wrought hardware

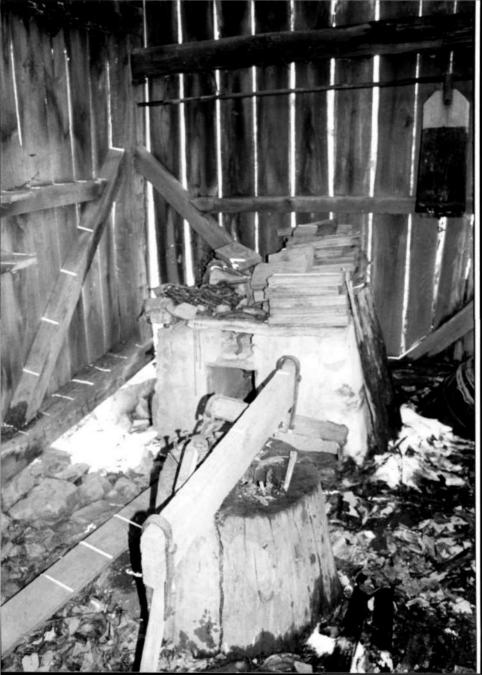
Ramsburg-Gover Farmstand Frederick Co. MD E. Wallace MOSHPO Blacksmith shop interior, forge remains, view foward SW corner

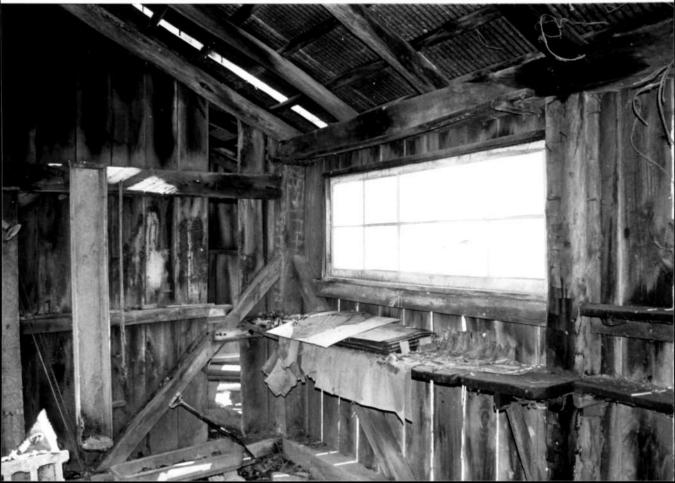
F. 4-49 Ramsburg - Gaver Farms tead Frederick Co., MD E. Wallace Blacksnith slop interior S wall workspace, view toward SE corner

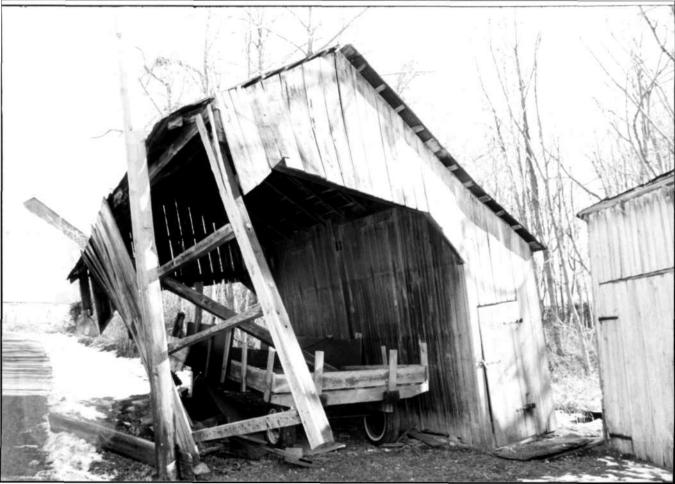
F-4-49 Ramsburg-Gaver Farmstead Frederick Co., mb E. Wallace MOSHPO Wagon shed covin crib, W elevation, showing damage to N devation, view W

Early in January 2003, a car hit the northeast corner of the wagon shed/corncrib causing significant damage to the structural integrity of the building. Although still standing at the time of the site visit, the building was in grave danger of collapse.

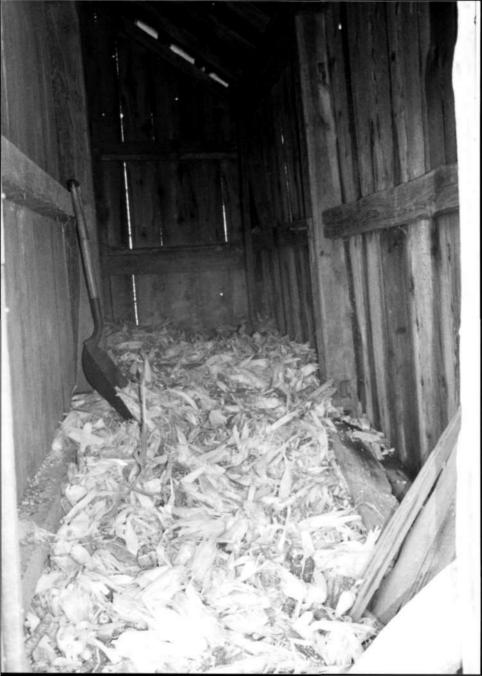
Rumsburg-Gaver Formstead Frederick Co., mo E. Wallace wagon shed/corneris, interior of cornerib, view W

Wagon shed/corn crib: The wagon shed/corn crib is located immediately east of the second group of three adjoining structures. It has vertical siding and a single corn crib on the south side. The roof is corrugated metal. Its date is probably 1875-1900.

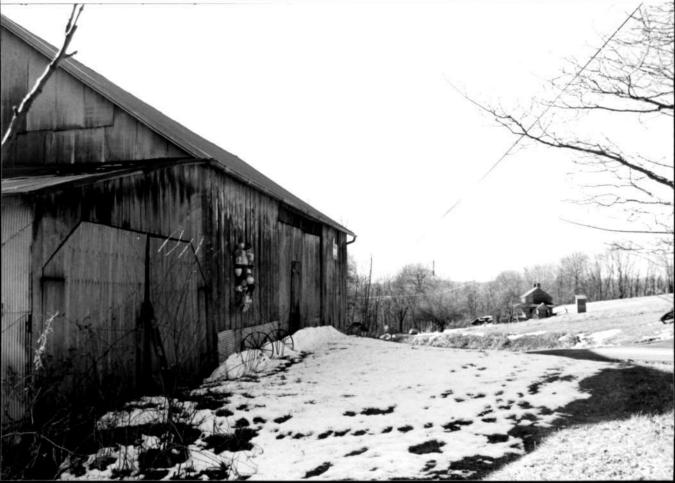
F-4-49 Ramsburg-Gaver Farmstead Frederick Comp E. Wallace 1-03 MOSHPO Barn, N elevation, view W toward dowestic con plex

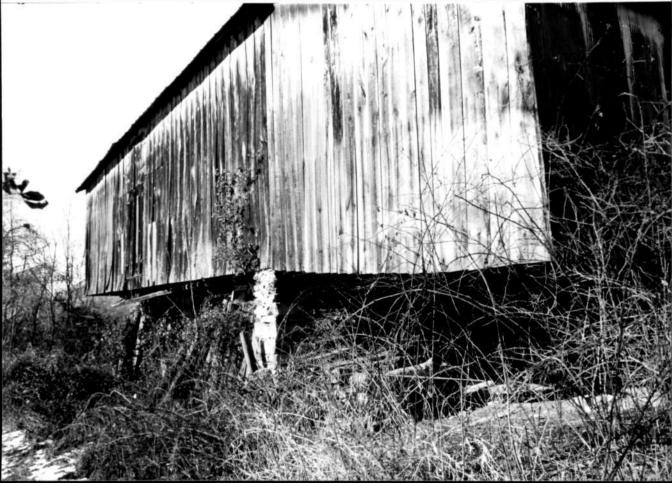
F-4-49 Ramsburg-Gaver Formstead Frederick (o., m) E. Wallace MOSHPO Barn, S elevation, view W

Barn: The frame bank barn is located at the east end of the farmstead, and is currently on a separately owned parcel (parcel 266; owner: Henry V. Chase, Jr., 10803A Highland School Rd., Myersville, MD 21773). It has horizontal siding with battens on the stall level facing south, with two glazed windows in the center and vertical board doors at the each end. The exterior of the upper section is vertical and the doors at the top of the ramp on the north elevation are double swing types. The roof is corrugated metal and the west elevation is also covered with corrugated metal.

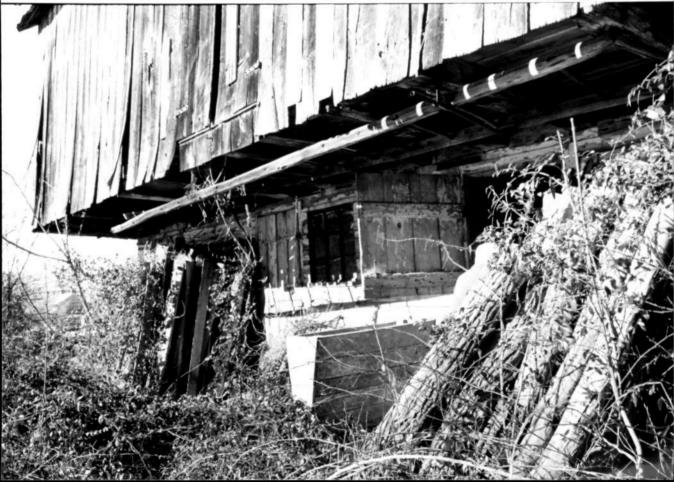
F 4-49 Ramsburg - Gover Farmstend Frederick Co., MD E. Wallace MASHPO Barn, S elevation, stalts below forebay, note split-rail ladder larging from forebay beams, view NW

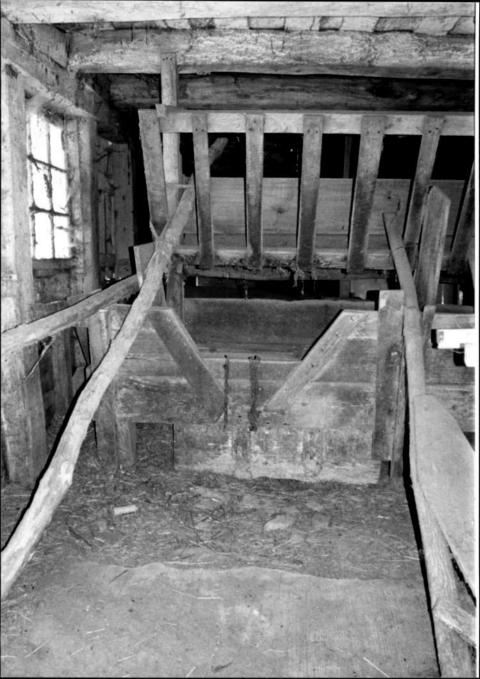
F-4-49 Ramsburg - Graver Farmstead Frederick Co., MD E. Wallace 1-03 MOSHPO Born, lower stalls interior, view toward w wall

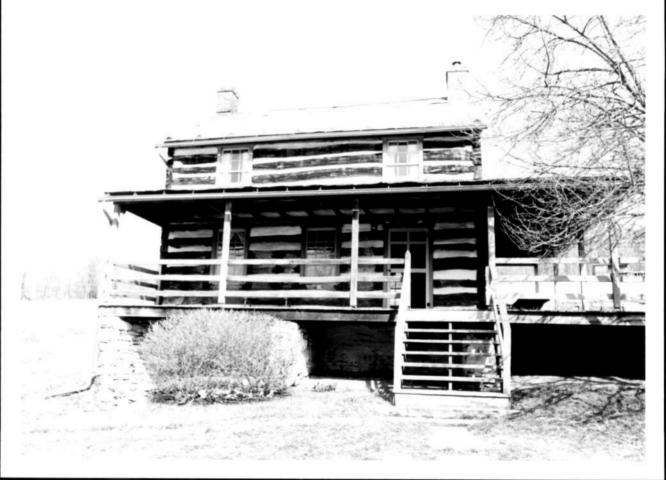
The dwelling faces south and has a three-bay first story with the entrance in the east bay. The second story has two bays. The windows are 6/6 on the first story, with mostly original glass. The entrance has a plain surround with a paneled door with a glazed upper section. The second story windows are 6/3, reflecting the low ceiling height of the interior. Across the south elevation is a rebuilt frame porch over an exposed stone foundation which extends toward the east. A fra two-story addition built about 1920 formerly stood on the east end of the 1 section; it was demolished about 1985, leaving the concrete floor in place with the rebuilt porch wrapped around to the east elevation. The gable roof is corrugated metal and interior chimneys are located at the east and west ends. The east and west elevations each have single bays, with a window in the west end and a doorway in the east end, which formerly led into the addition. The east gable above the porch roof is covered with german siding. The north elevation has two bays on each The exposed log structure has been restored and plastered between the logs. The logs on all elevations have vertical channels cut into the surface which held studs to which german siding was attached, a feature which was probably added during the last quarter of the 19th century or early 20th century and removed during the 1980's rehabilitation.

F-4-49. Ramsburg-Gaver Farmstead Frederick County Photo: Janet Davis March 1992 Neg. loc. Md. SHPO, Crownsville, Md. Sooth elevation

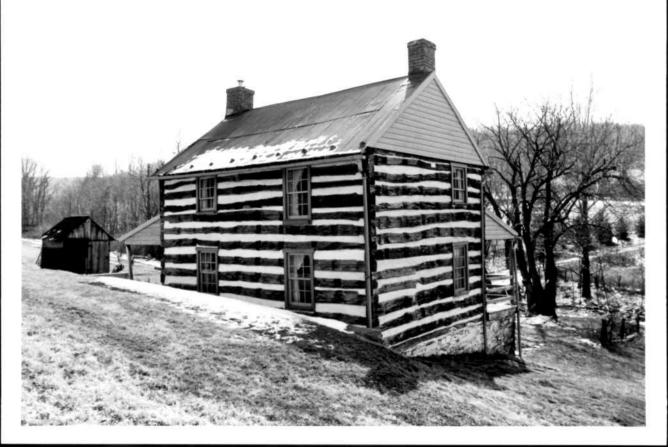
F-4-49 Ramsburg-Bover Formstead Frederick County Photo: Janet Davis March 1992 Neg. loc. : Md. SHPO, Crownsville, Md. Northwest corner view

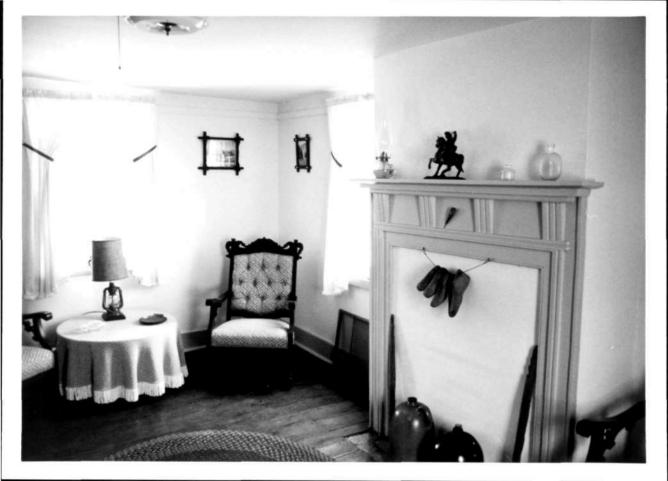
F-4-49 Ramsburg - Gover Formstead Frederick County Photo: Janet Dovis March 1992 Nea. loc.: Md. SHPO, Crownsville, Md. Patlor 3/8

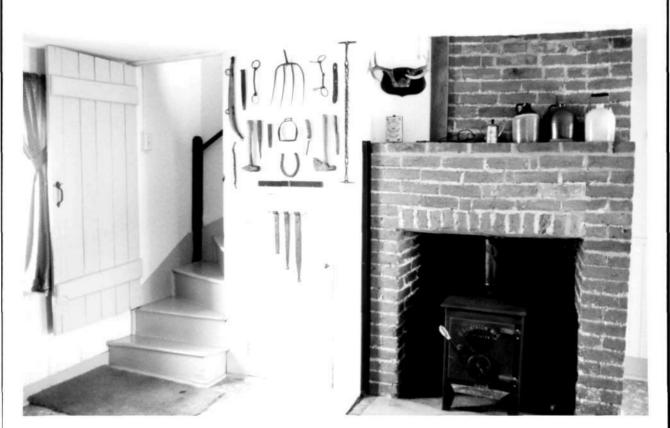
F-4-49 Ramsburg - Gover Formstead Frederick County Photo: Janet Davis March 1992 Neg. loc.: Md. SHPO, Crownsville Md. Kitchen fireplace and stair

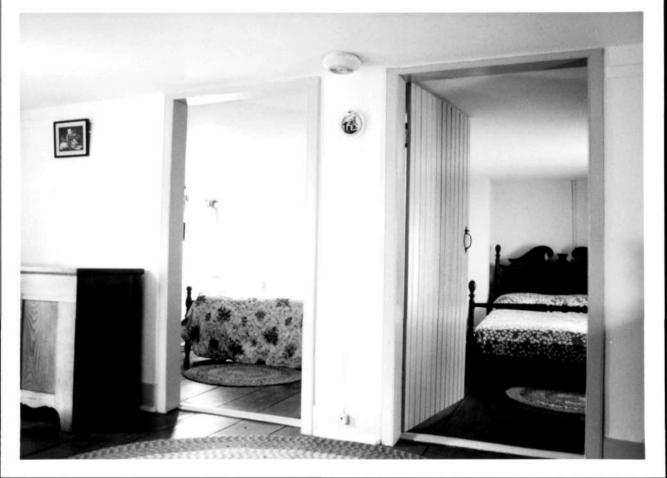
F-4-49 Ramsburg - Gaver Farmstead Frederick County Photo: Janet Davis March 1992 Neg. loc .: Md. SHPO, Crownsville, Md. Second floor hall and chambers

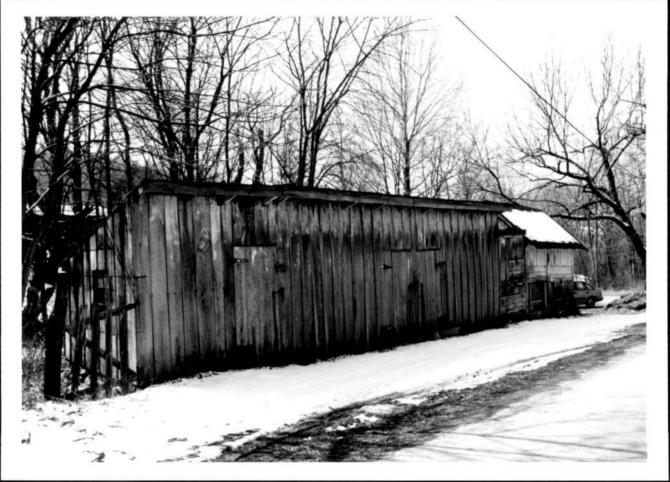
F-4-49 Ramsburg-Gover Farmstead Frederick County Photo: Janet Davis March 1992 Neg. loc.; Md. SHPO, Crownsville, Md Feed shed, chicken house, hag born (L to R) north elevation 6/8

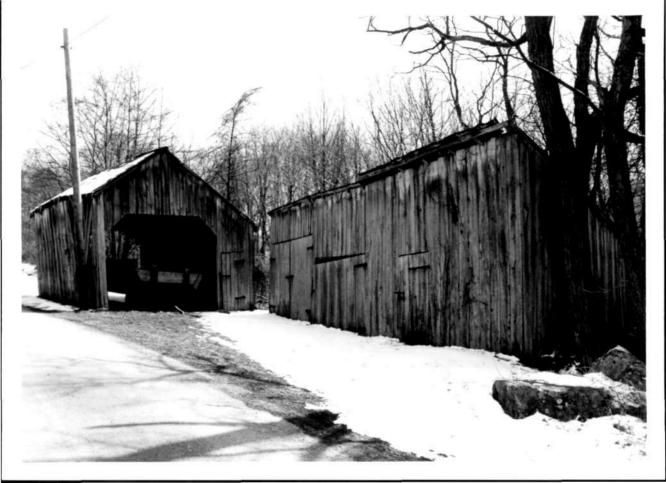
F-4-49 Ramsburg-Gover Farmstead Frederick County Photo: Jonet Davis March 1992 Neg. loc.: Md. SHPO, Crownsville, Md. Wagon shed/corn Crib, garace, Wagon shed, blacksmith stop (L to R), view from west 7/8

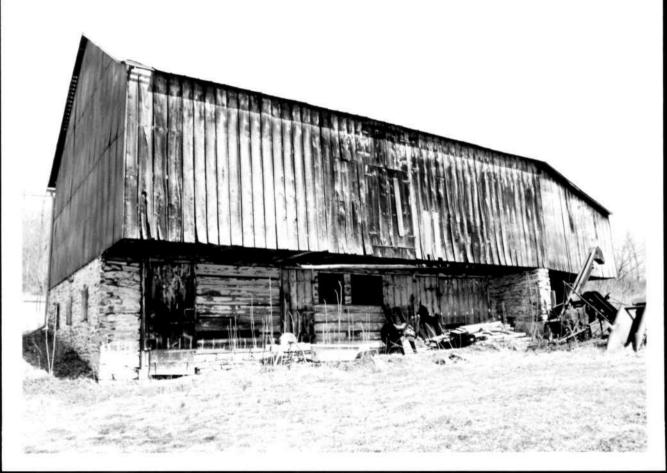
F-4-49 Ramsburg-Gaver Formsteod Frederick County Photo: Jonet Davis March 1992 Neg. loc .: Md. SHPO, Crownsville, Md. Born, South elevation 8/8
